EDGE PERFORMANCE
AIRCRAFT ENGINES - FUEL INJECTION KITS - TURBO CONVERSIONS

ALERT SERVICE BULLETIN

CHECKING OF SECOND COMPRESSION RING ON 84.00mm PISTONS

ASB-EP912STi-001

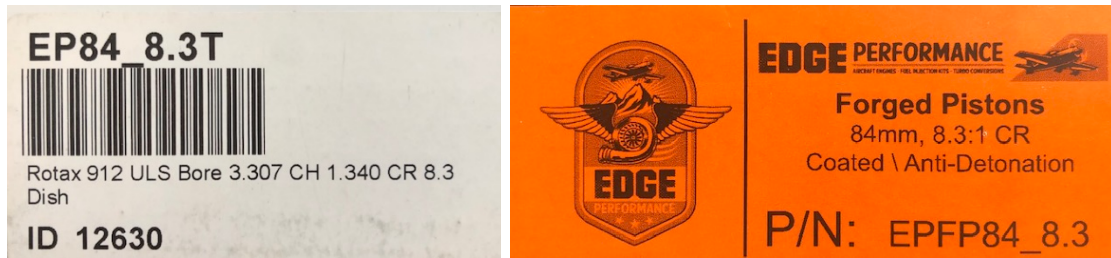
Identifying the affected piston part numbers

For those with EP912STi engines, or for those who have purchase forged 84.00mm 8.3:1CR pistons with the black skirt coating, and the grey ceramic top coating between the 06/2018 to 02/2019, an inspection of the second compression ring is necessary. If a narrow ring (1.16mm marked with N, *PN: 21-GNH08400*) is installed, all (4) pistons must be replaced before the next flight. If the wide ring (1.46mm marked with N100, *PN:RS1110-3307*) is installed, the engine can be reassembled and put back into service.

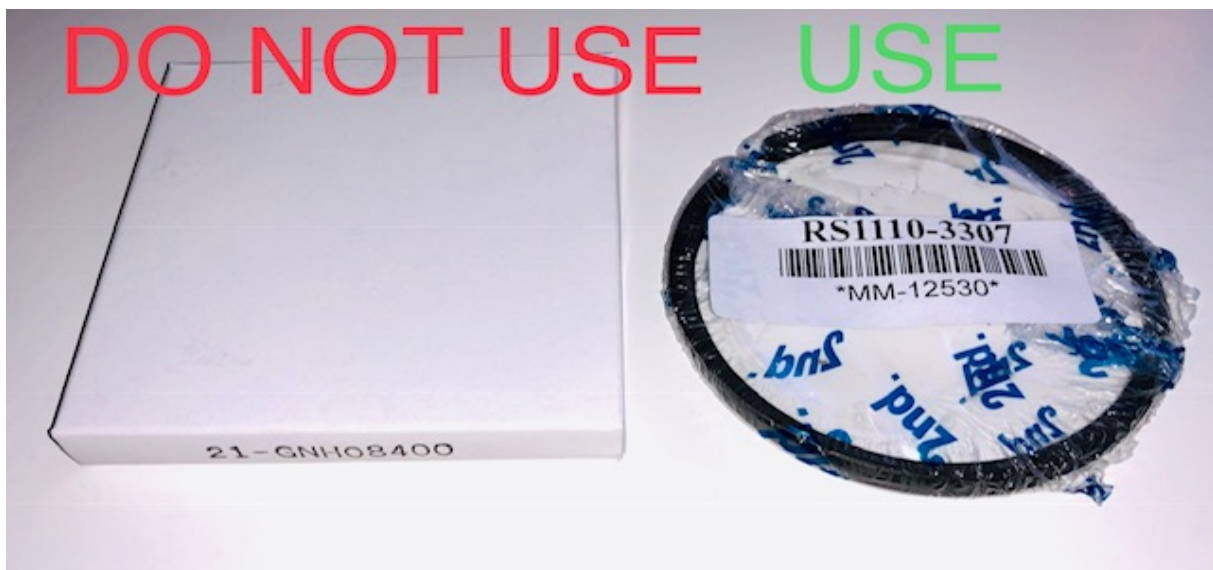
Showing the white box with the narrow second ring, and the bag with the proper wide rings

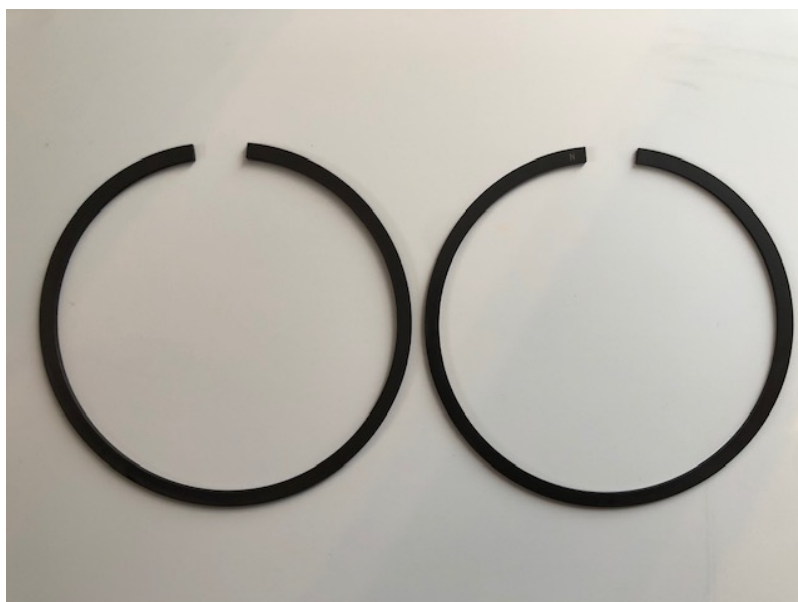
The two rings look similar, but the good one has N100 laser etched in the top, and the bad one has a N etched onto the ring end

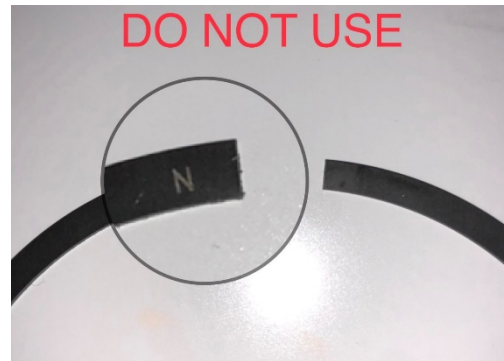
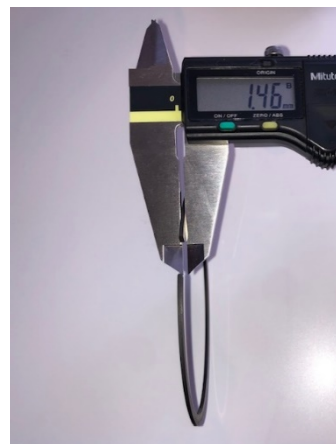
Showing the laser etched marks for easy identification

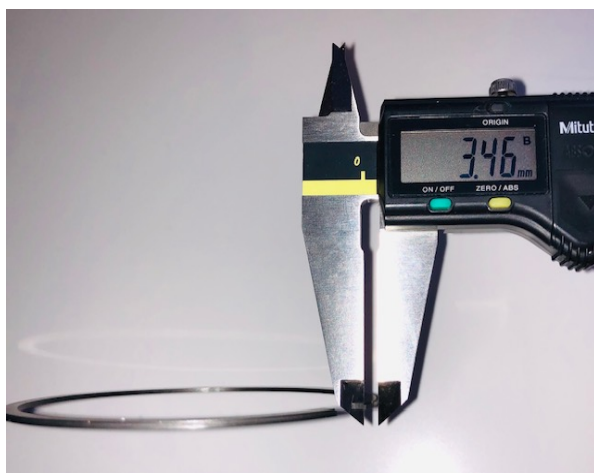
Showing the dimensions of the good wider rings

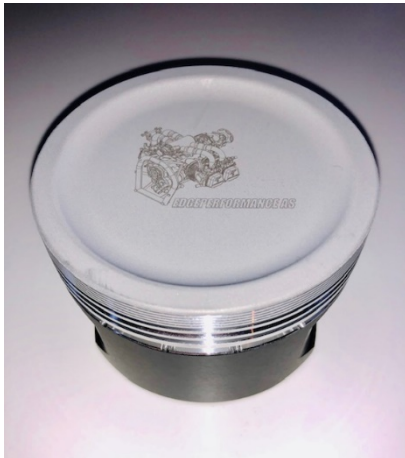
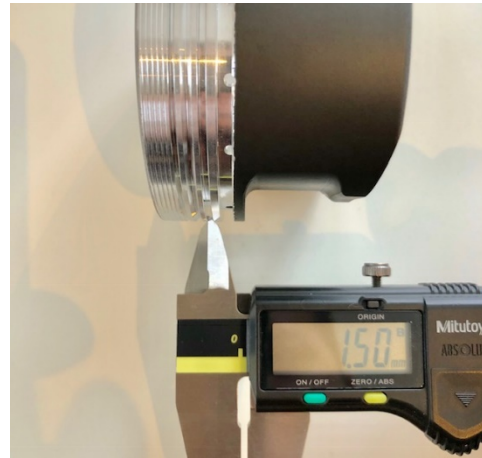
Showing the dimensions of the wrong narrower rings

Showing the possibly affected pistons and which groove to verify the width of

If the incorrect second compression ring measuring 1.16mm is installed, (4) new pistons with new rings, wristpins, circlips and gaskets must be replaced. Contact you nearest EP dealer to claim your **FREE OF CHARGE** replacement parts. All the removed parts shall be destroyed and discarded, preventing them to get back into service.
