ALERT SERVICE BULLETIN

CHECKING OF THE OIL SCAVENGE PUMP HOUSING & OIL PUMP SHAFT INSTALLED ON EP912STi (155HP) & EP914Ti (126HP) ENGINES

ASB-EP912STi/EP914Ti-002

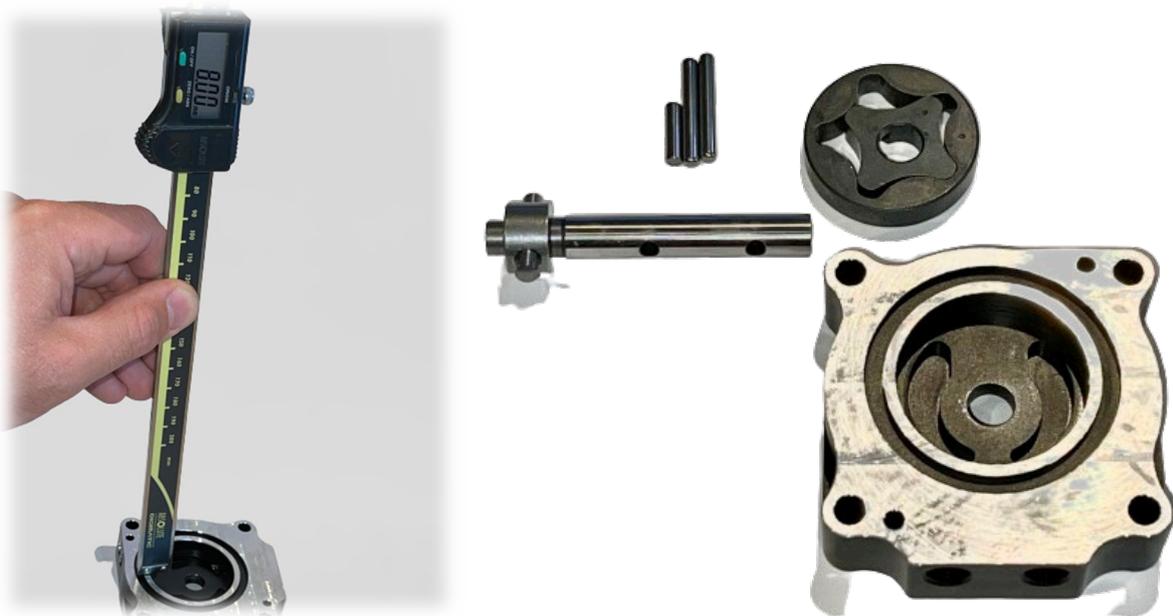
Fig.1

Scavenge pump assy.

1. Loosen and disconnect the two M10 banjo bolts on the bottom of the scavenge pump housing.
2. Undo the 4x M6 socket head bolts on the front of the oil pump cover.
3. Remove the pump cover and pull out the gear rotor set.
4. Remove the 4x15.8 needle pin on the pump shaft and slide off the scavenge pump housing.
5. Use the back side of you vernier caliper and measure the bore depth as per fig.01
6. If necessary, replace the scavenge pump housing, and install it back in reverse order with new O-rings. Apply a small bead of Loctite 5910 or equivalent silicon gasket sealant where the 30x2.5 O-ring mates to the crankcase.
7. Re-torque the 4x M6 socket head bolts to 12Nm.
8. Perform a test run on ground to ensure there is no oil leaks from the oil pump assembly, and no smoking exhaust once the turbo and exhaust has reached operating temperature.

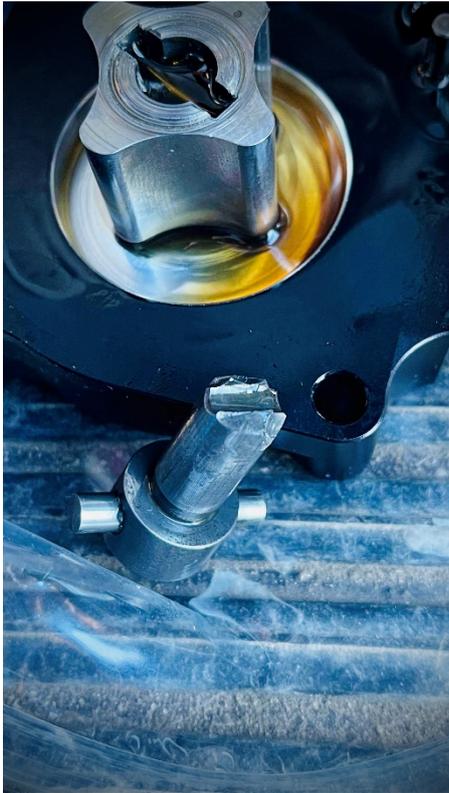
There have been some manufacturing deviations resulting in a too great clearance between the scavenge rotor set and the pump cover. This results in a lack of suction during low rpm operations and idle. As a result of this the oil scavenge sump on the turbocharger has not been scavenging sufficiently resulting in internal oil leaks within the turbine and compressor housing, and smoking exhaust while idling. In some rare cases. the pin bores on the pump shaft have also been machined 0,5-0,1mm to large, resulting in one case where a shaft broke.

Broken shaft

Inspect and if necessary, replace the oil scavenge pump housing and/or shaft. Contact your nearest EP dealer for replacement parts.

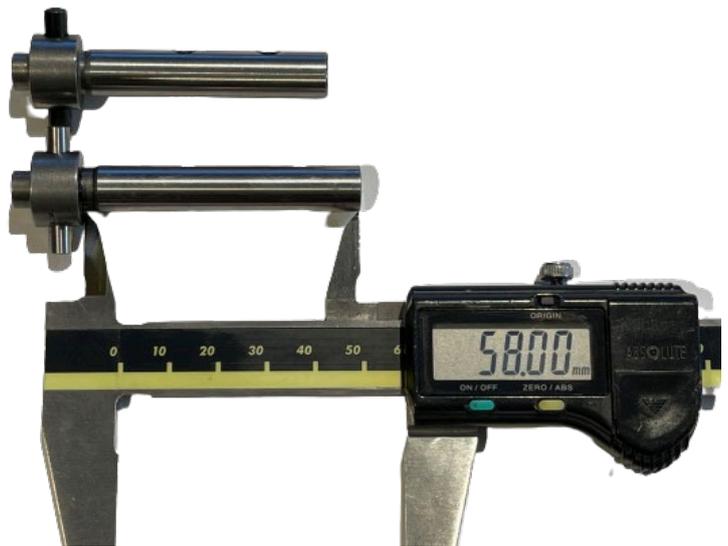
How to identify affected shafts (Those over 52mm)

Remove and inspect the scavenge pump housing and shaft. Use a digital vernier caliper and measure the bore depth where the scavenge gear set sits. It should measure between 8.00-8.05mm in depth. Those with 8.20-8.35mm depth should all be replaced within the next **25 hours** of flight time. The same applies to the shafts where the pin bores measure above 4.15mm.

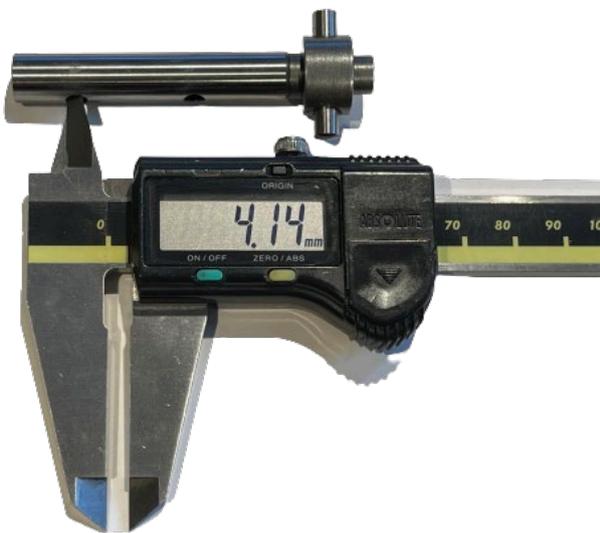
Good shaft bore diameter

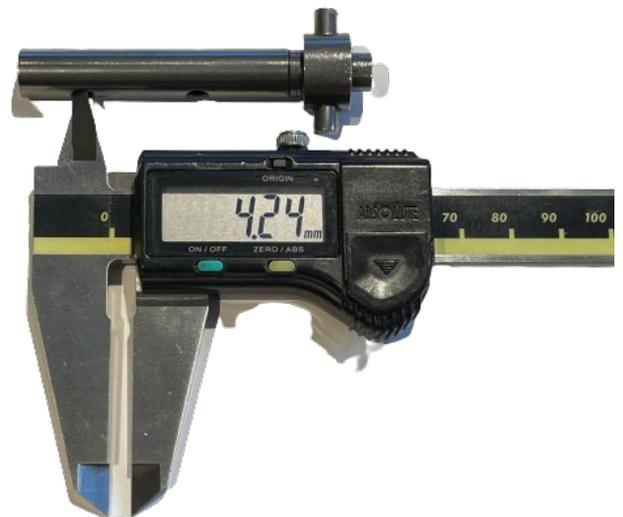
Bad shaft bore diameter
